Test Report

No. 1530-002-15 dated 05.02.2015

Improvement Factor of Pipe Clamps in the Test Stand

Two-Screw-Clamp
BIS Schelle 2S with noise insulating inserts made of
EPDM-rubber on measuring tubes ½", 1", 2", 4" and 6"

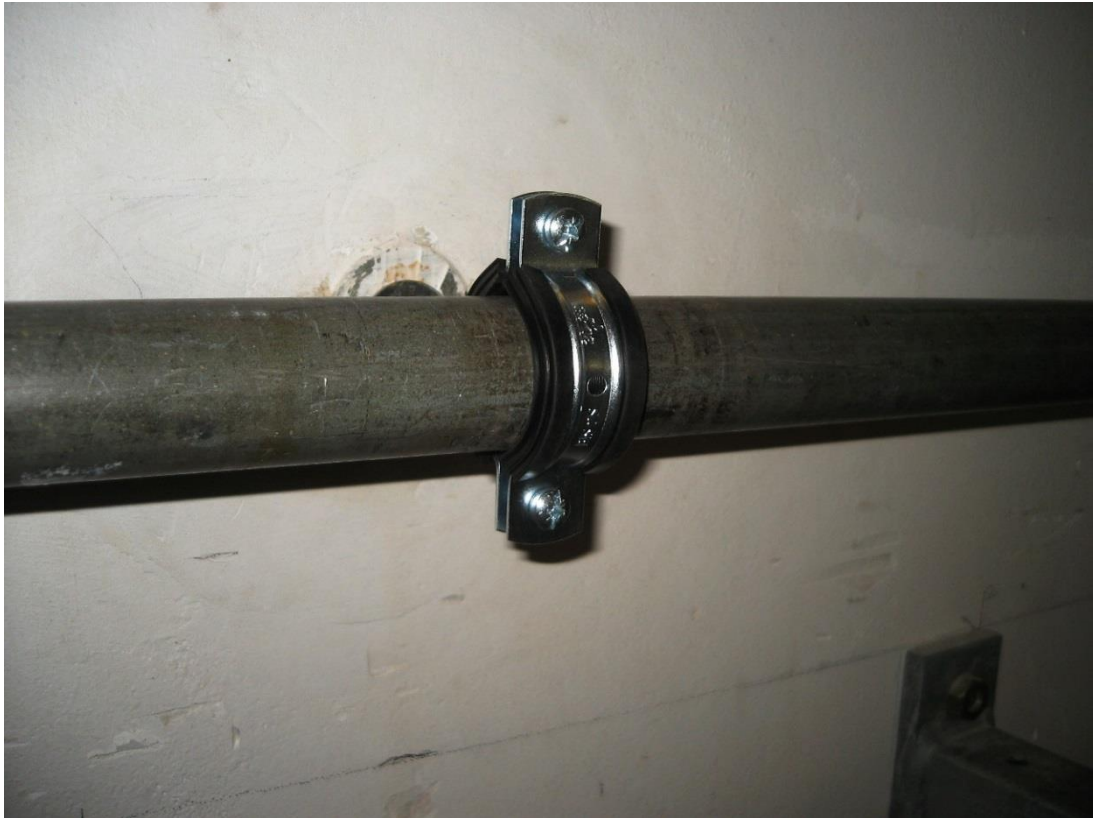
Fig. 1: Meas. 2: BIS Schelle 2S, 1" (30 - 35mm), connection M8/10, with EPDM-rubber (20 x 3,70 mm)

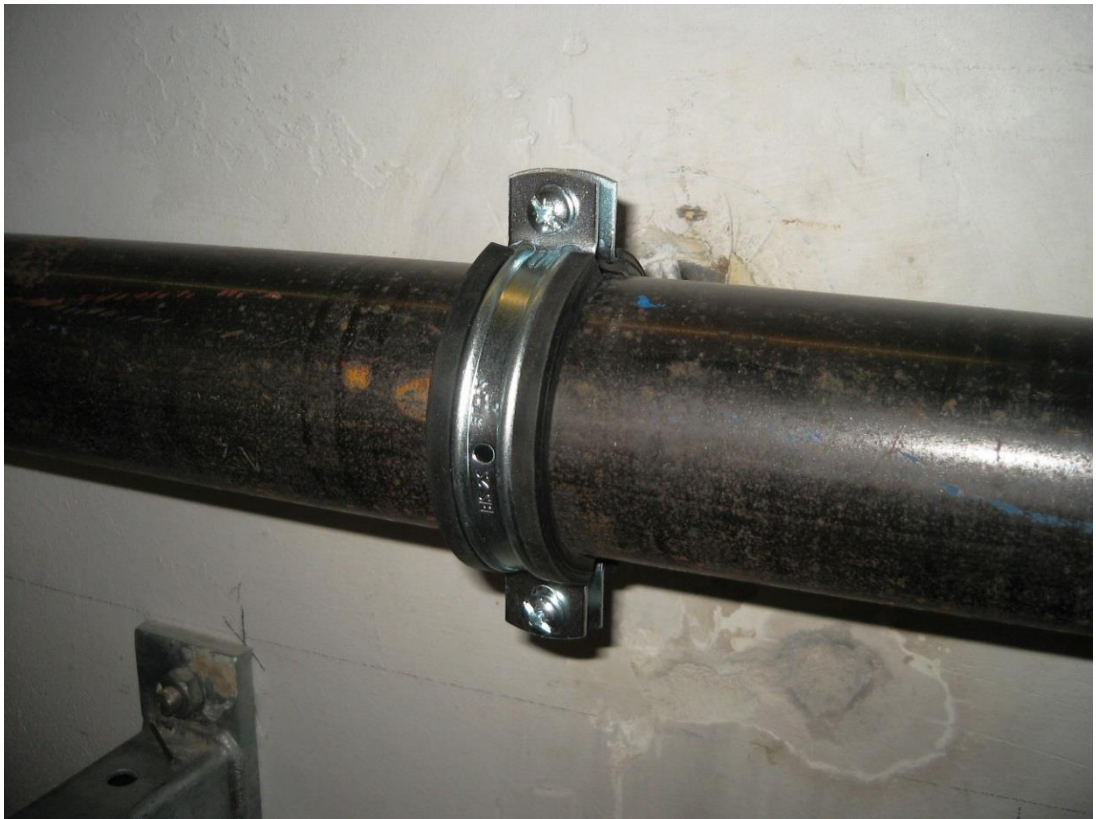
Fig. 2: Meas. 3: BIS Schelle 2S, 2" (57 - 63mm), connection M8/10, with EPDM-rubber (20 x 4,00 mm)
